ORIOLE ESTATES
CITY OF LAUDERDALE LAKES, FLORIDA

2018 CASE STUDY

RECONSTRUCTION OF COLLAPSED NEIGHBORHOOD CANAL BANKS

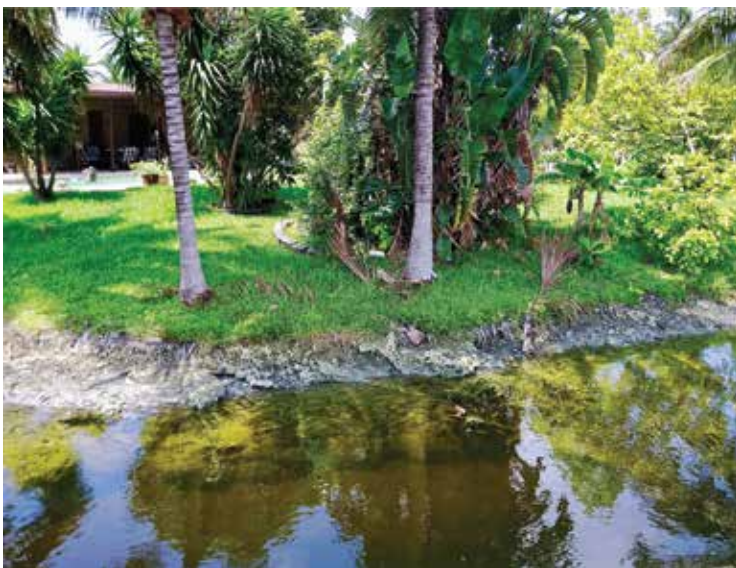
Homeowners in Oriole Estates watched their properties erode away and appealed to the city of Lauderdale Lakes for help.

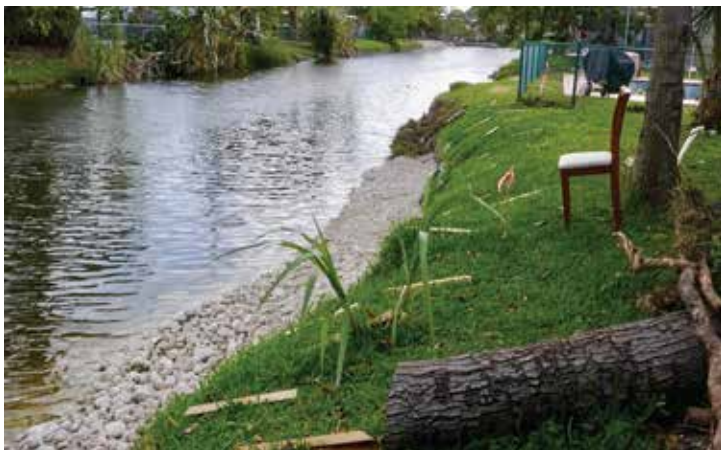
Setting up our staging area behind each home with our stakes before the material arrives.

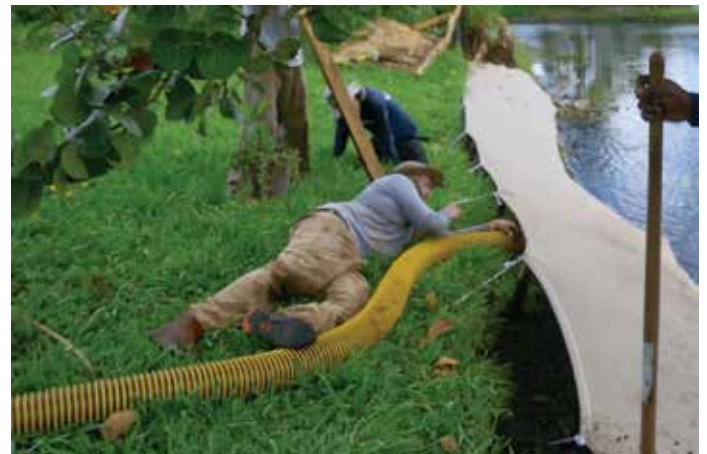
The SOX system is filled with blow-in mulch in this area behind the homes.

The Lake and Wetland crew installed the Shoresox bioengineered erosion control system using their patented subsurface anchoring system. Once staked in and stabilized, the mesh was pumped full of black dirt, compost material and topsoil. The mesh surface was then topped with St. Augustine grass squares. The shoreline is expected to last several decades.

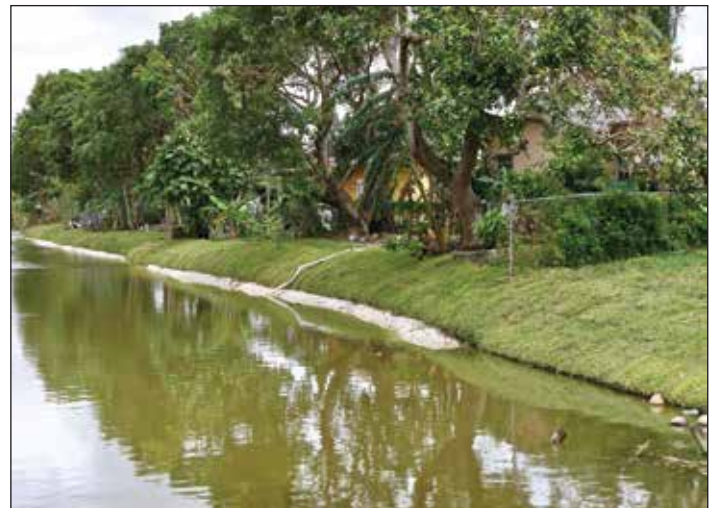
SOX Erosion Solutions is sodded over leaving a seamless look to the shoreline and immediately halting any further erosion.

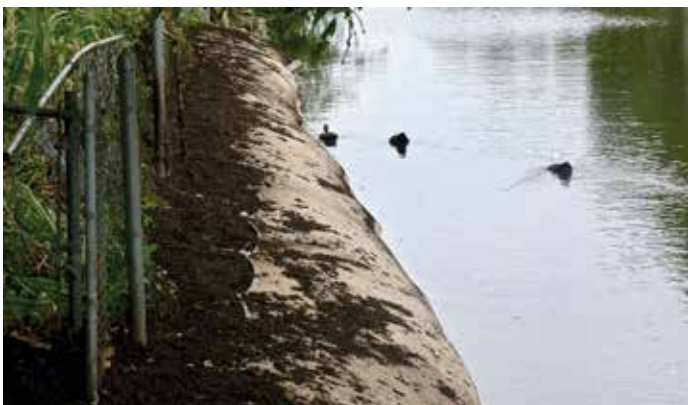
Once the SOX System is filled it is then staked subsurface to the secure shoreline before it is sodded over.
